## Site Inspection Report Summary

**Property Address:** 6231 PA-88 Finleyville, PA 15332

**Inspection Date:** 06/10/2020

## **Photo Report of Koteles Garage**

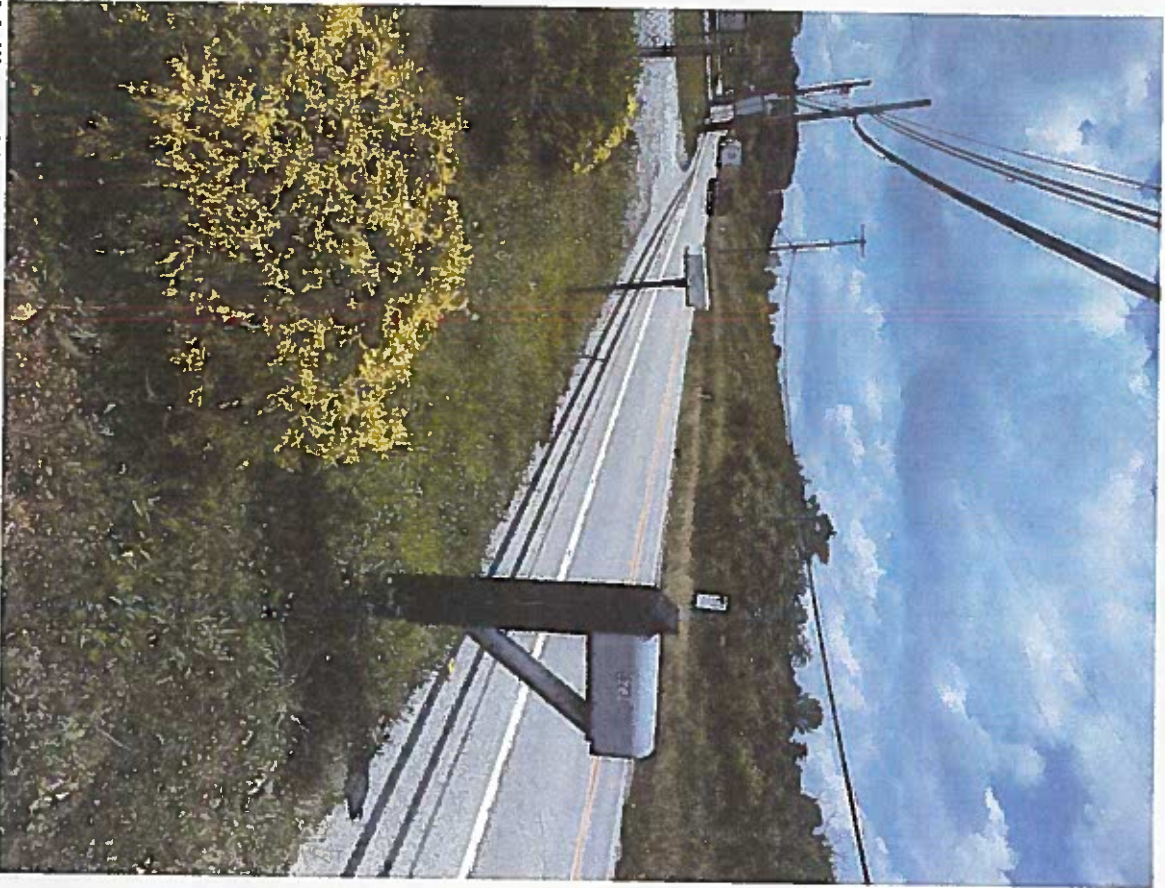
Mailbox with street address of property. Mismatched unpainted wood holding it up.

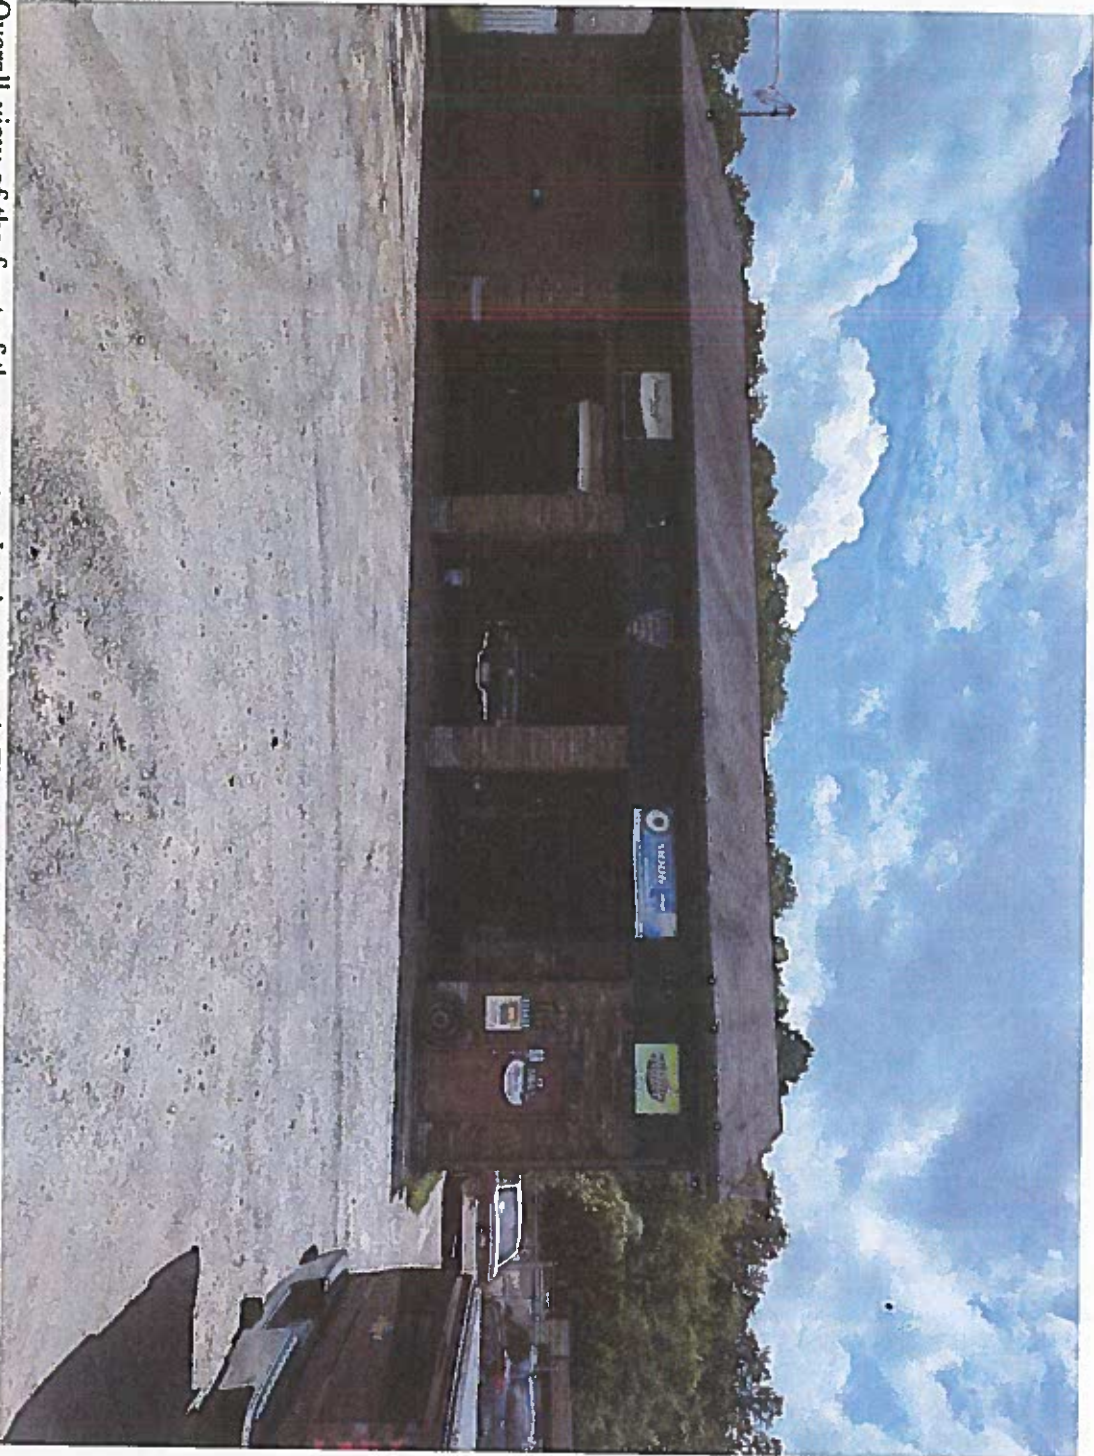
Overall view of the front of the property. Lot is unpaved. The gravel is thin. Parking spots are unpainted. Exterior lights were not confirmed to be operational during the site visit.

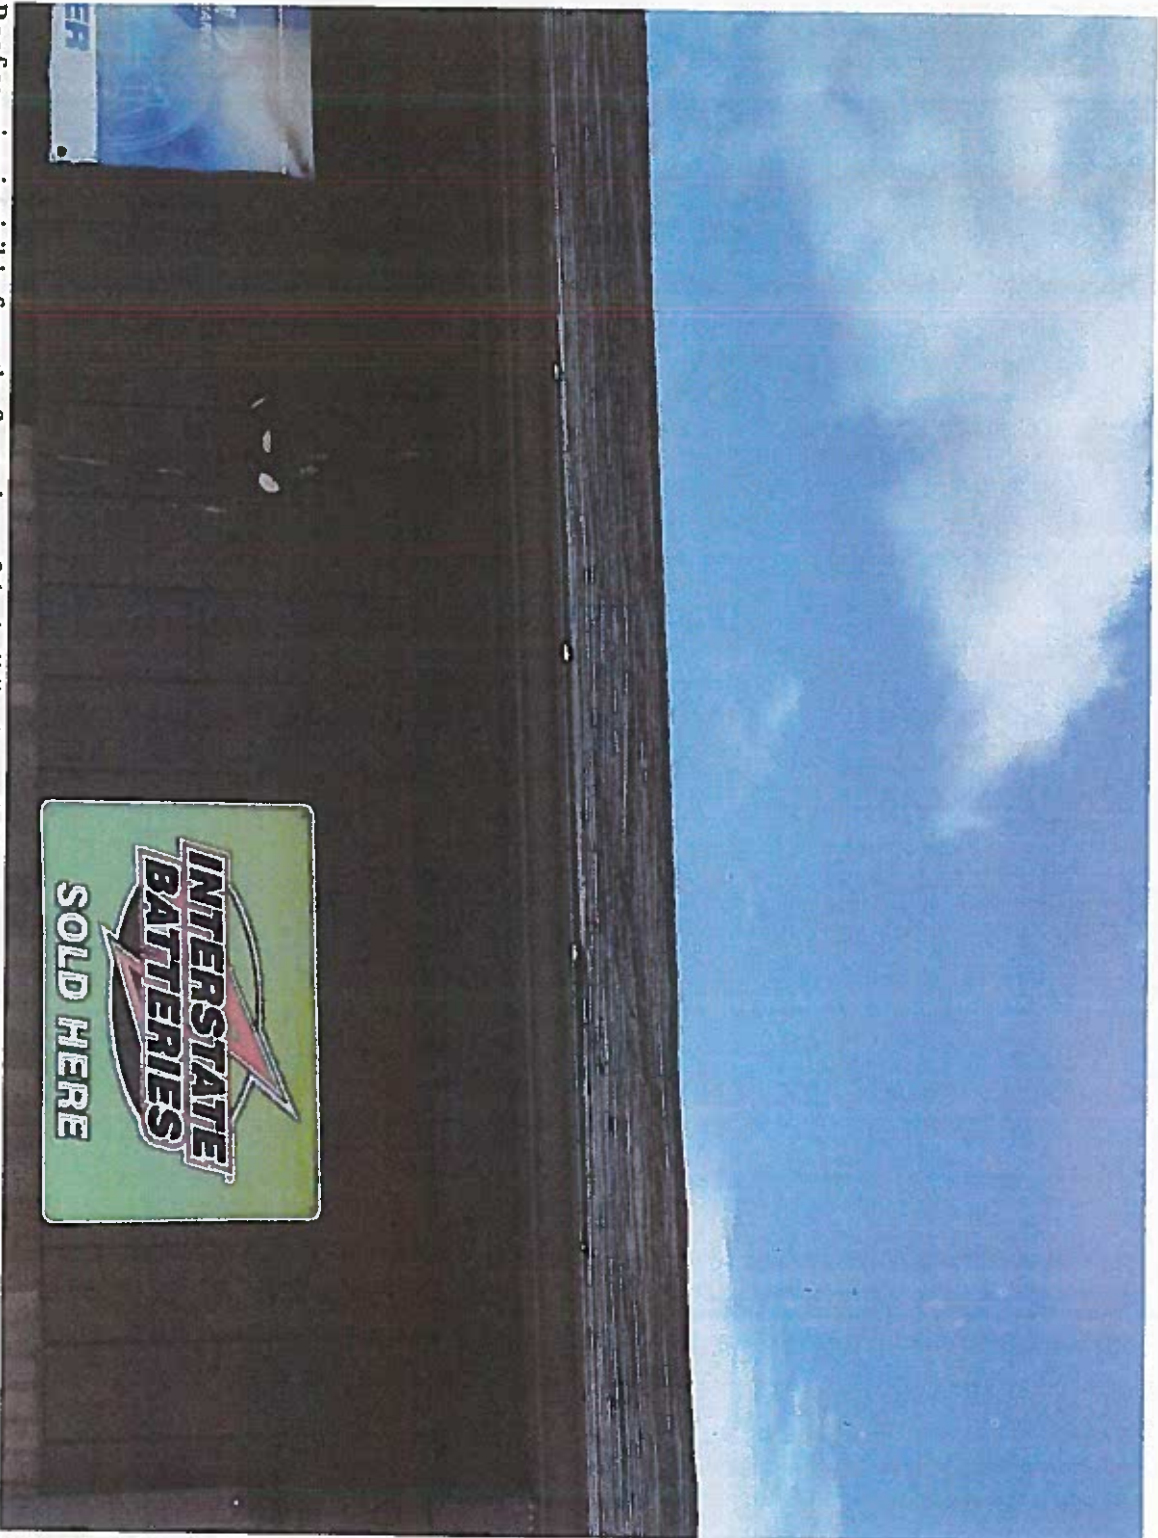
Overall, the roof is in poor condition. The roof of the structure containing the main garage bays closest to PA SR-88 was observed first. Viewed from the "front-side" of the building, there was visible roof sagging concentrated at a depression in the roof shingles. Viewed from the "rear-side" of the building, there was obvious deterioration in the condition of most of the roof shingles. Damage to the roof flashing was observed along the sides of the building. Wood paneling under the roof structure needs repainted. An unsecured roof downspout was observed during the inspection. Failure to correct the roof will lead to further damage and a diminution in property value.

Roof sagging is visible from the front view of the building's roof shingles.

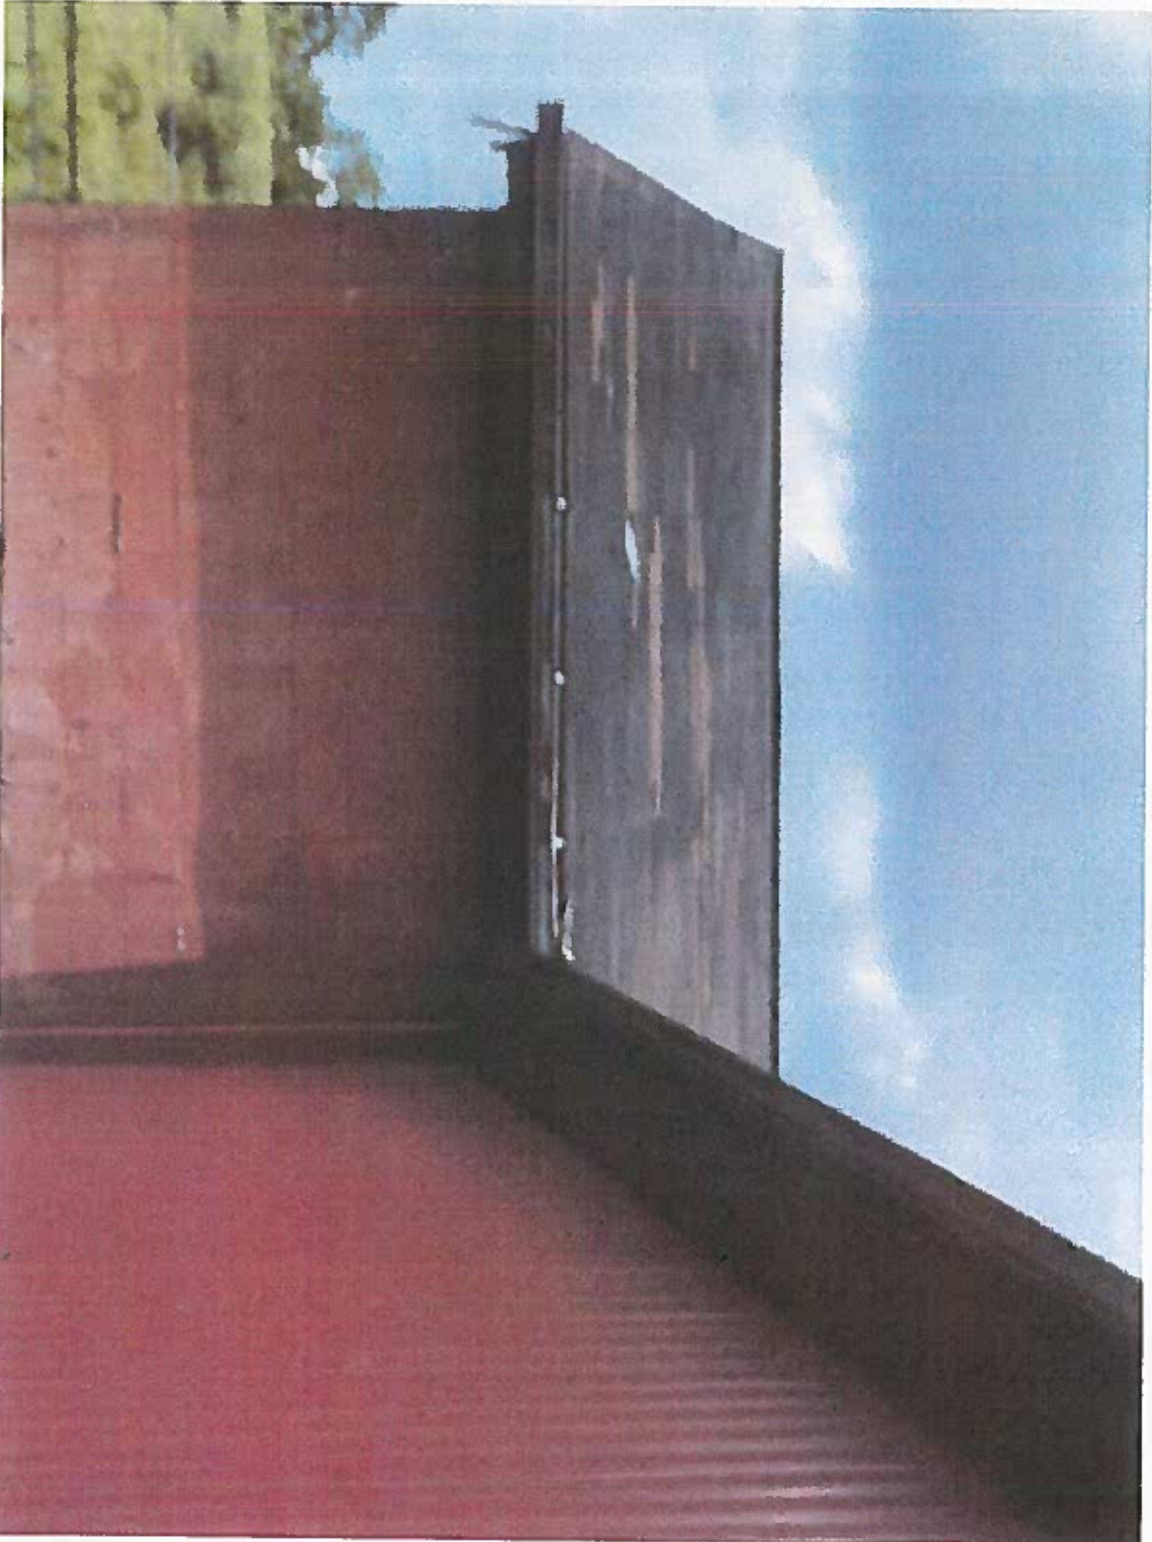
Extensive roof shingle wear and tear is evident from a rear view of the building facing towards PA SR-88

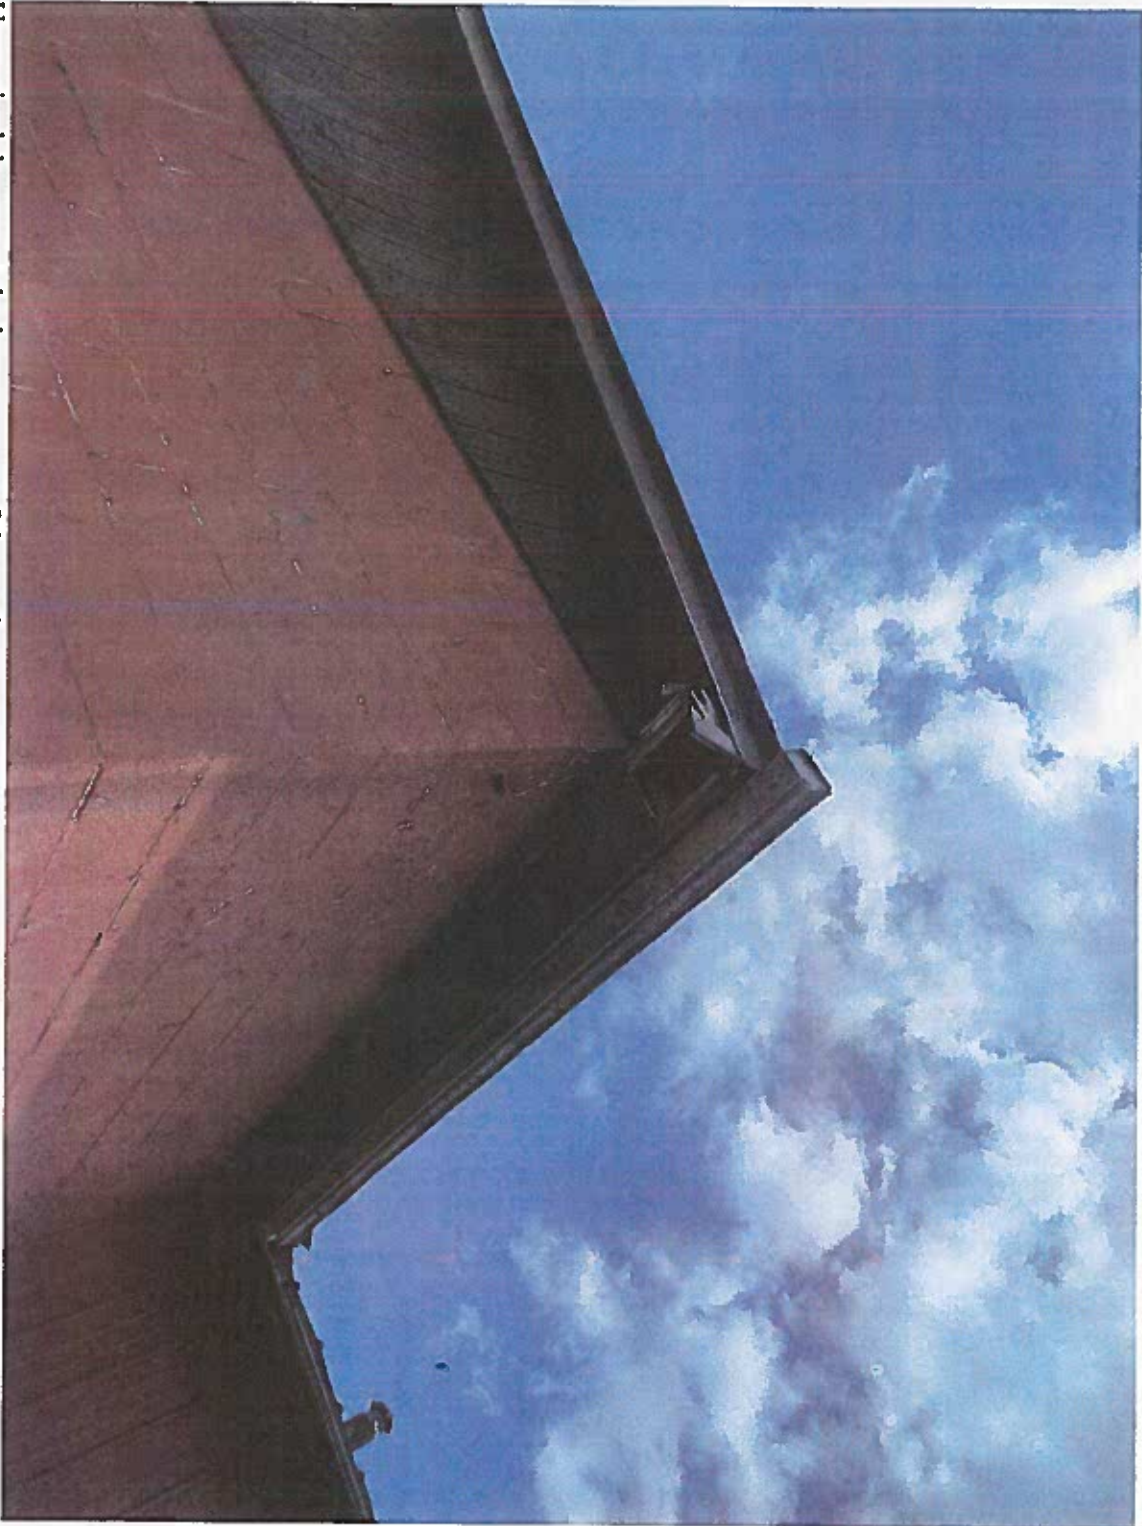
Unrepaired damage at the lower corner of the roof.

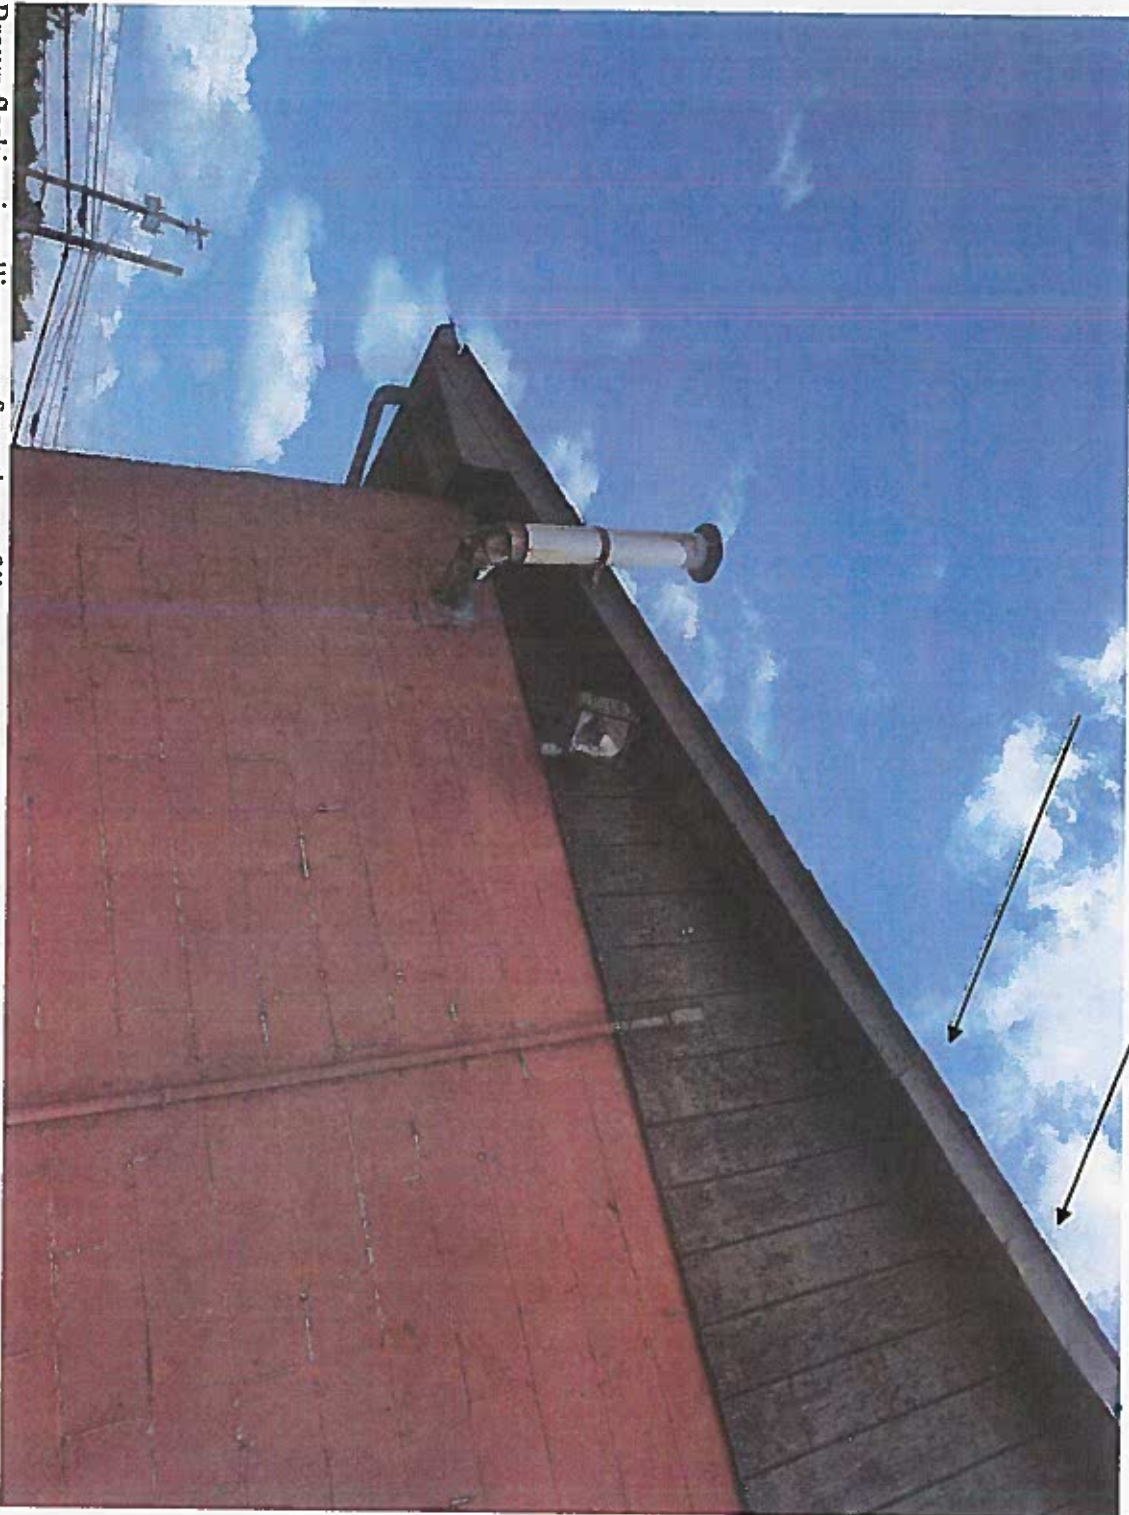
Brown flashing is pulling away from the roof line

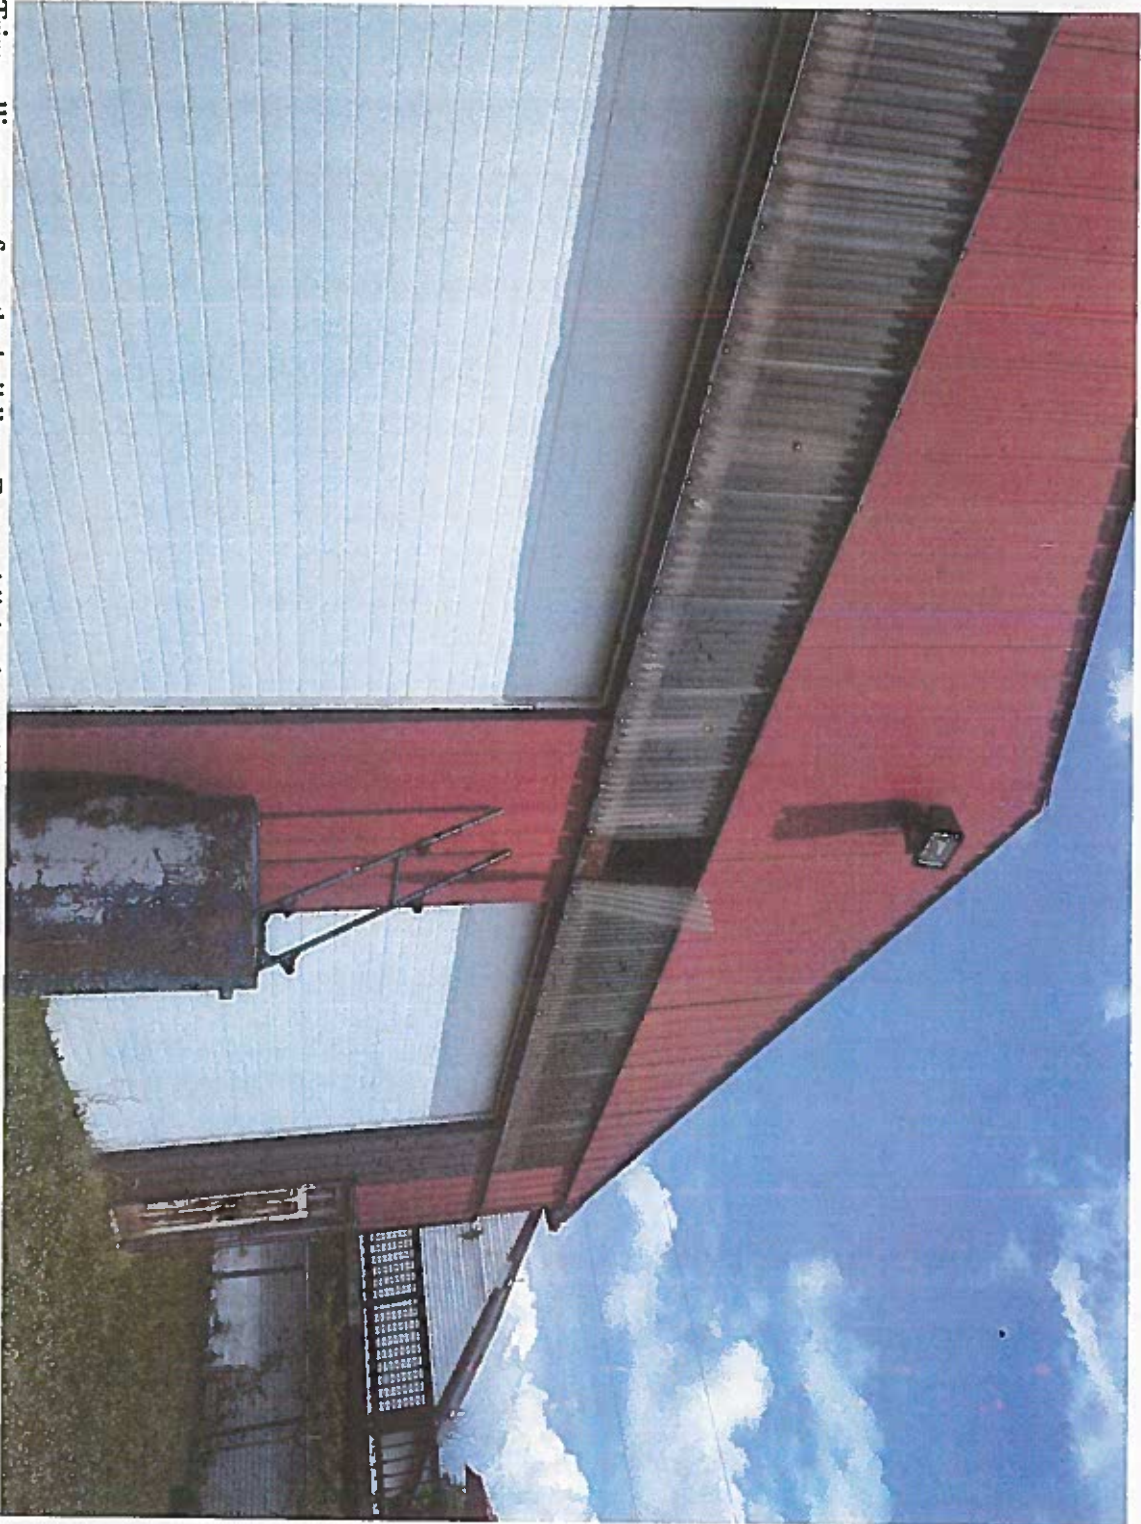
Trim pulling away from the building. External light above the trim was not confirmed to be operational.

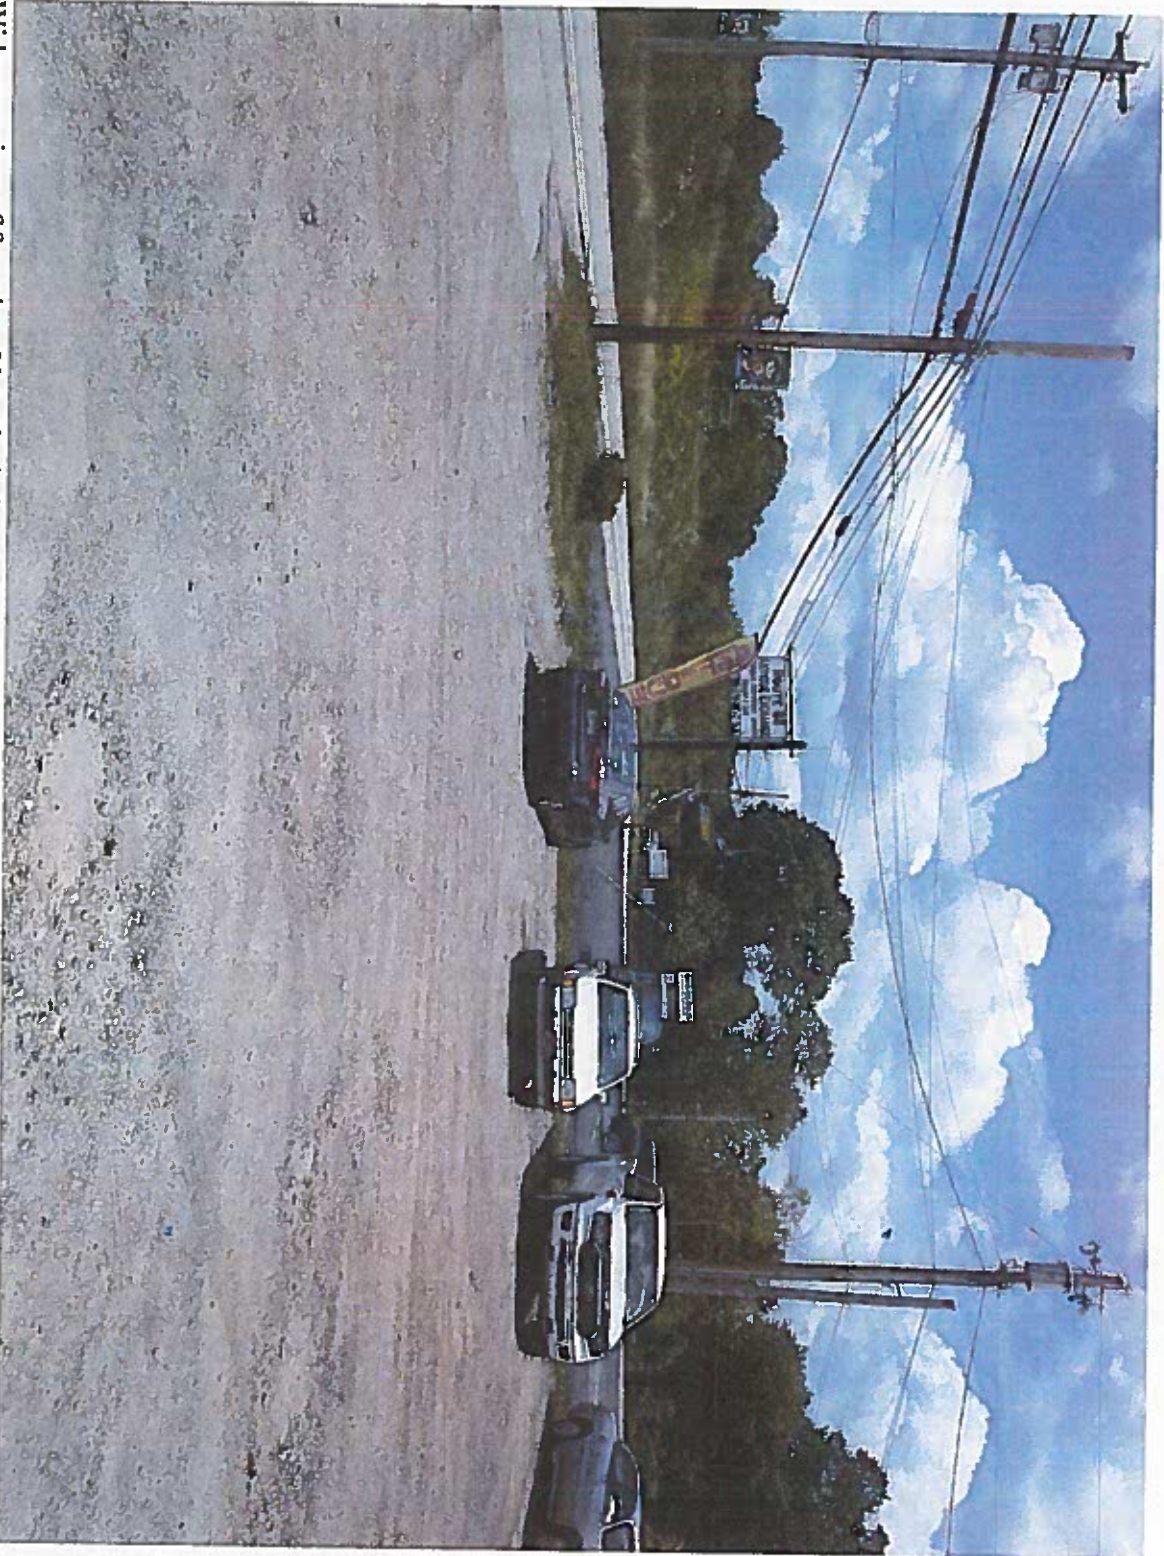
I observed that the automotive repair facility parking lot was mostly unpaved and lacked a contiguous impervious surface. (Impervious surface being defined as a parking lot constructed of asphalt, concrete, and / or cement). The surface material of the parking lot was primarily gravel. However, the gravel was noted to be thinly distributed throughout the parking lot. Potholes and ruts in the parking lot were clearly visible. The few areas of the parking lot that had impervious surfaces had observable damage due to cracking.

Wide overview of front lot. Note the holes, ruts, and defects in the parking lot.

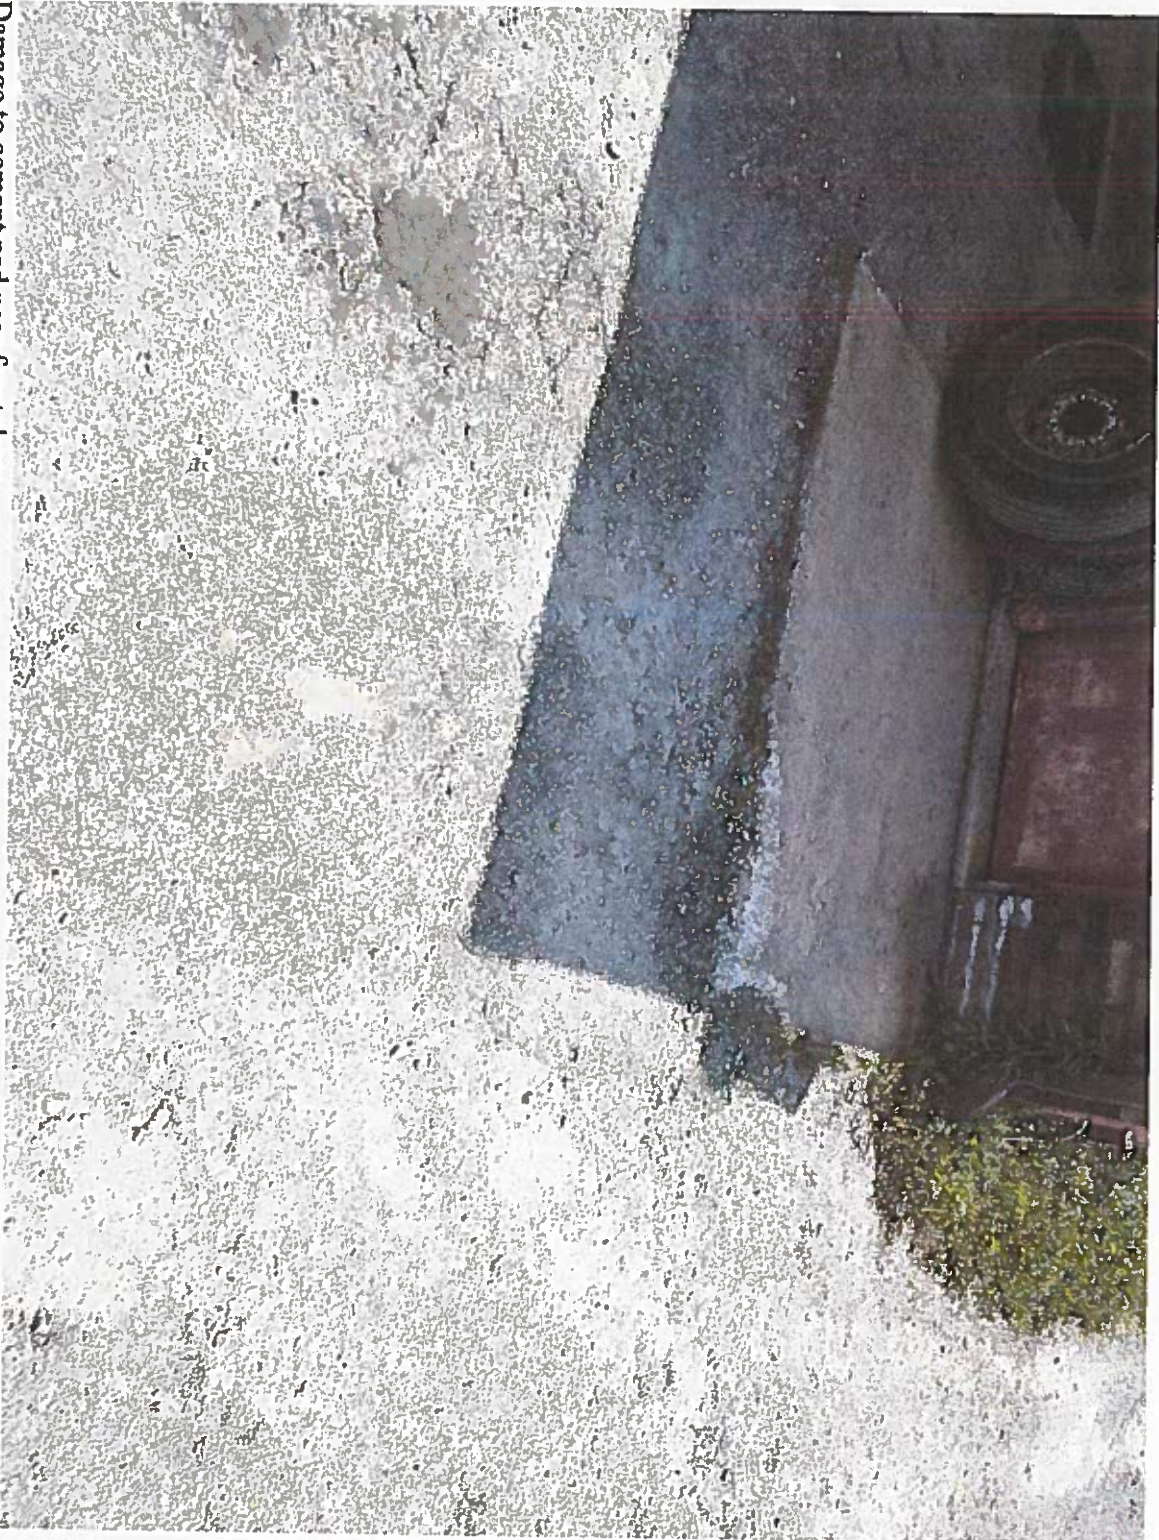
Damage to cement pad near front door.

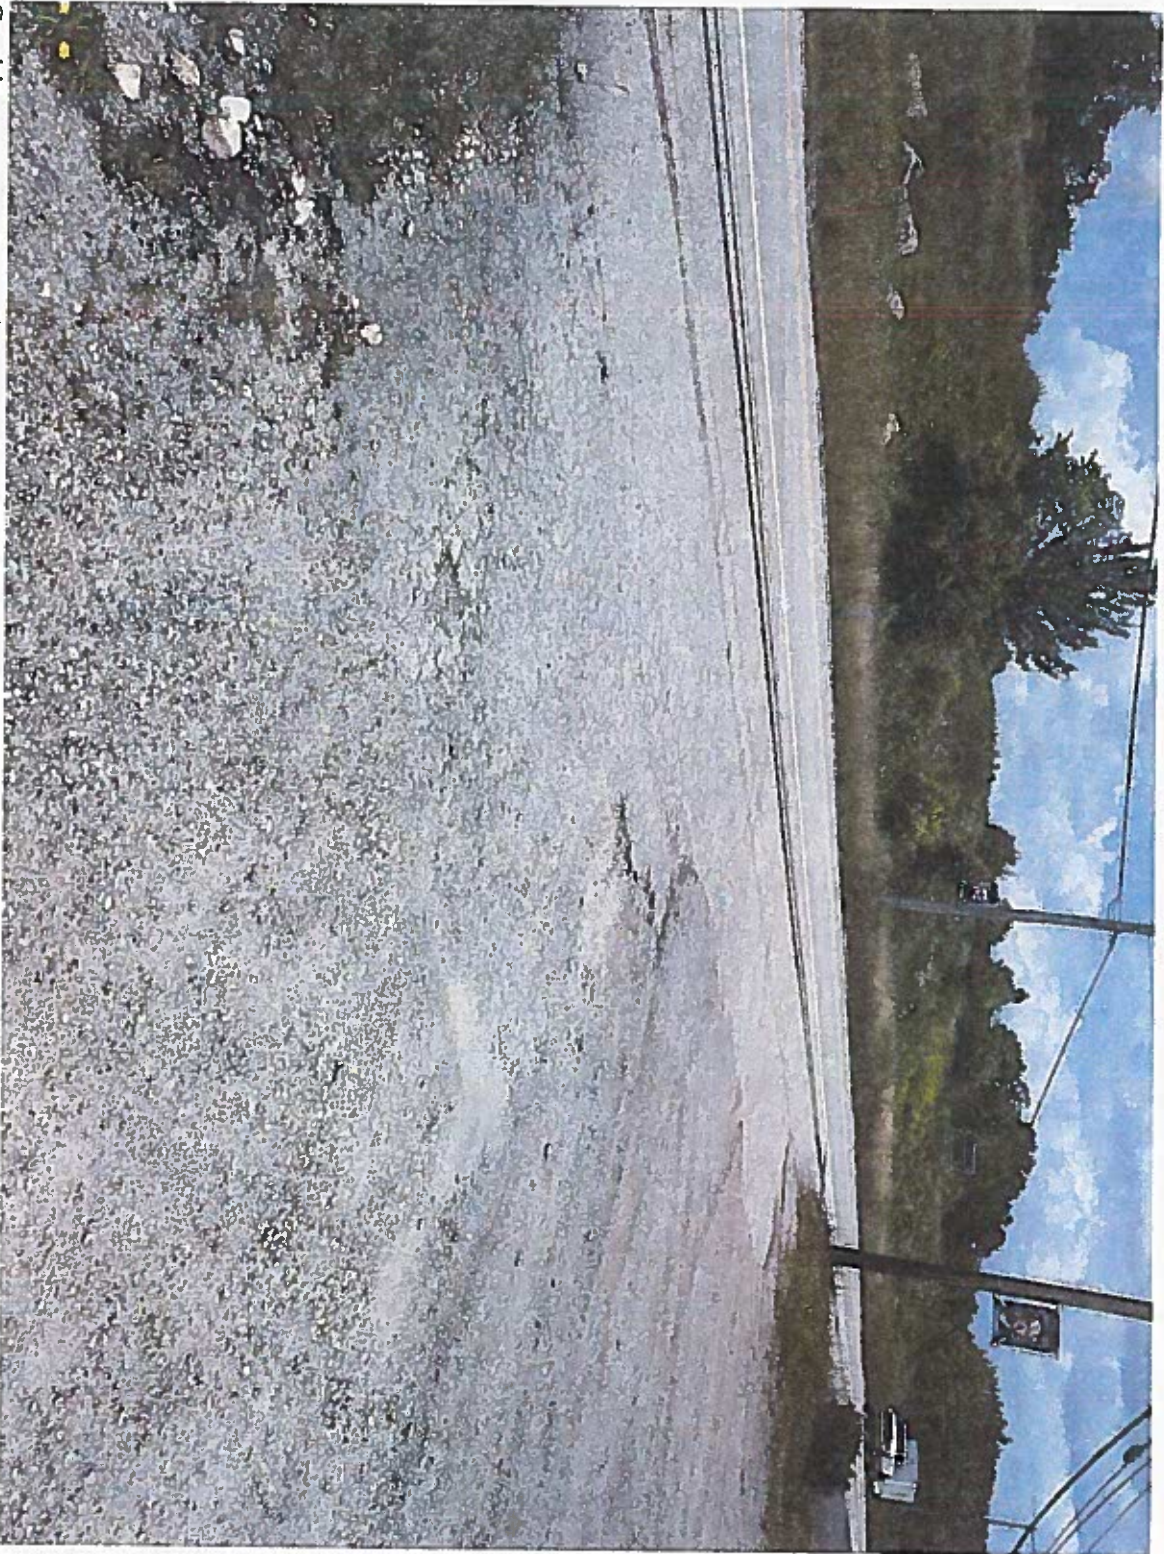
Cracking pavement near the access transition between SR-88 and Koteles Garage

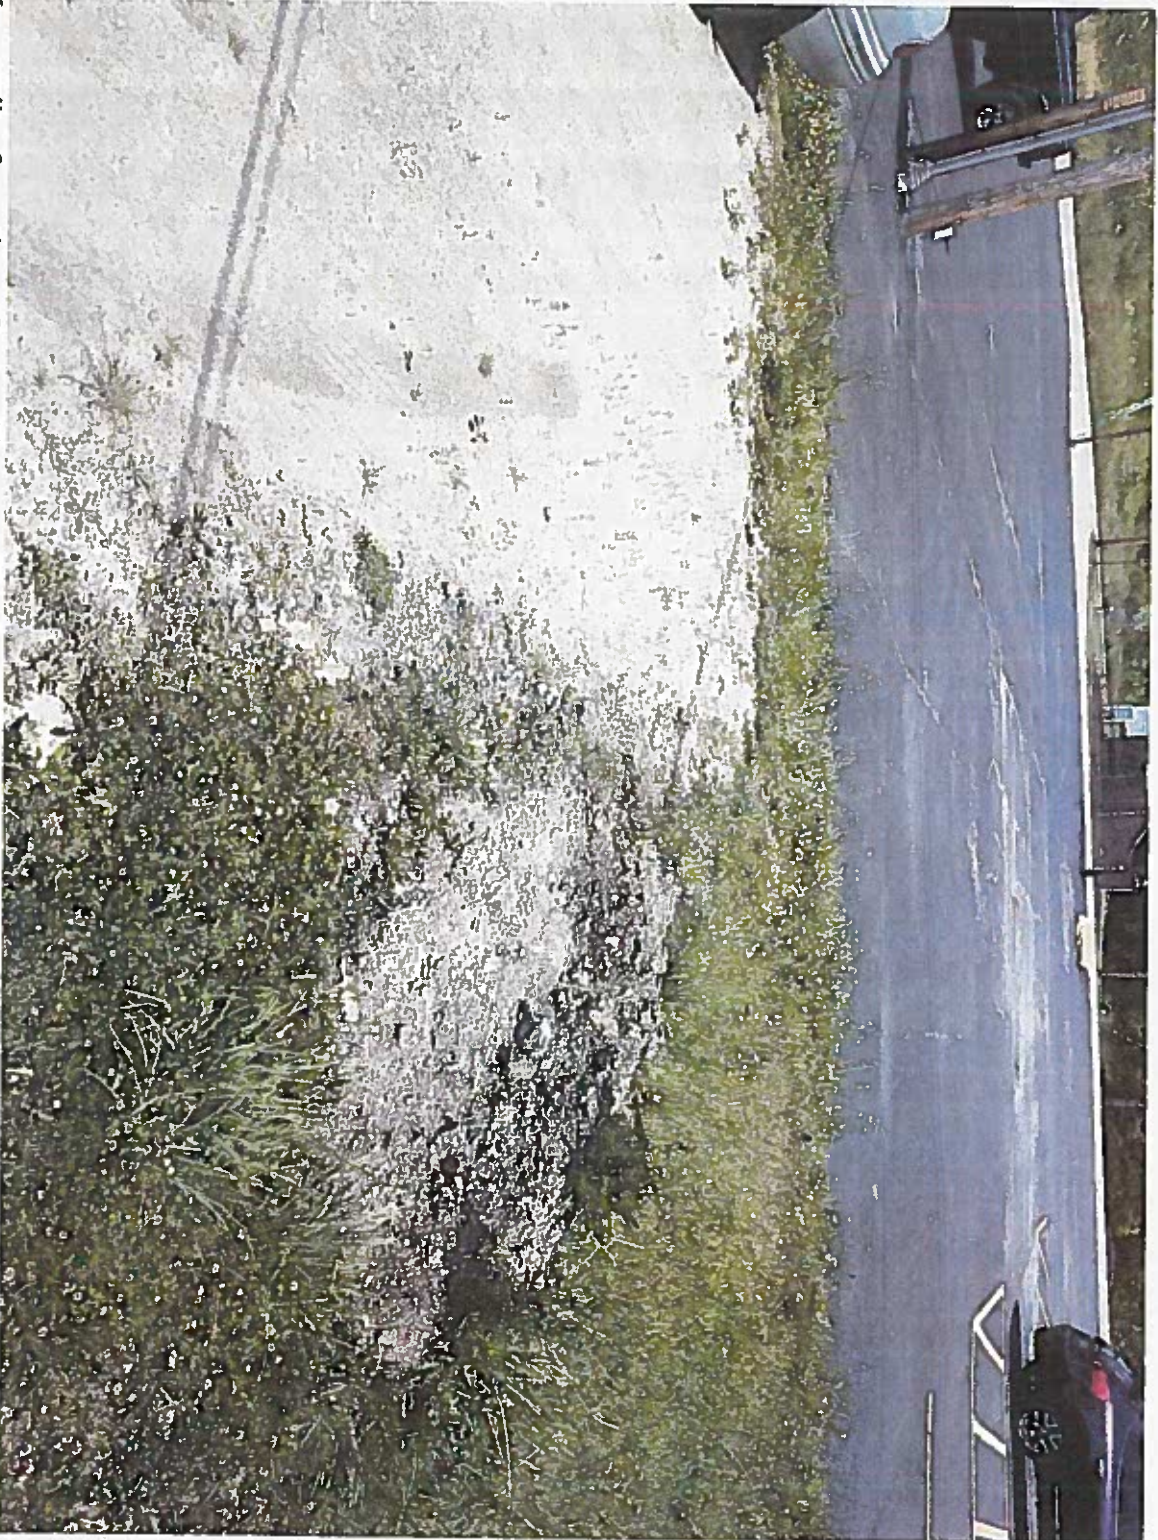
Loose pile of gravel near front parking spot. Note how thin the parking lot gravel is.

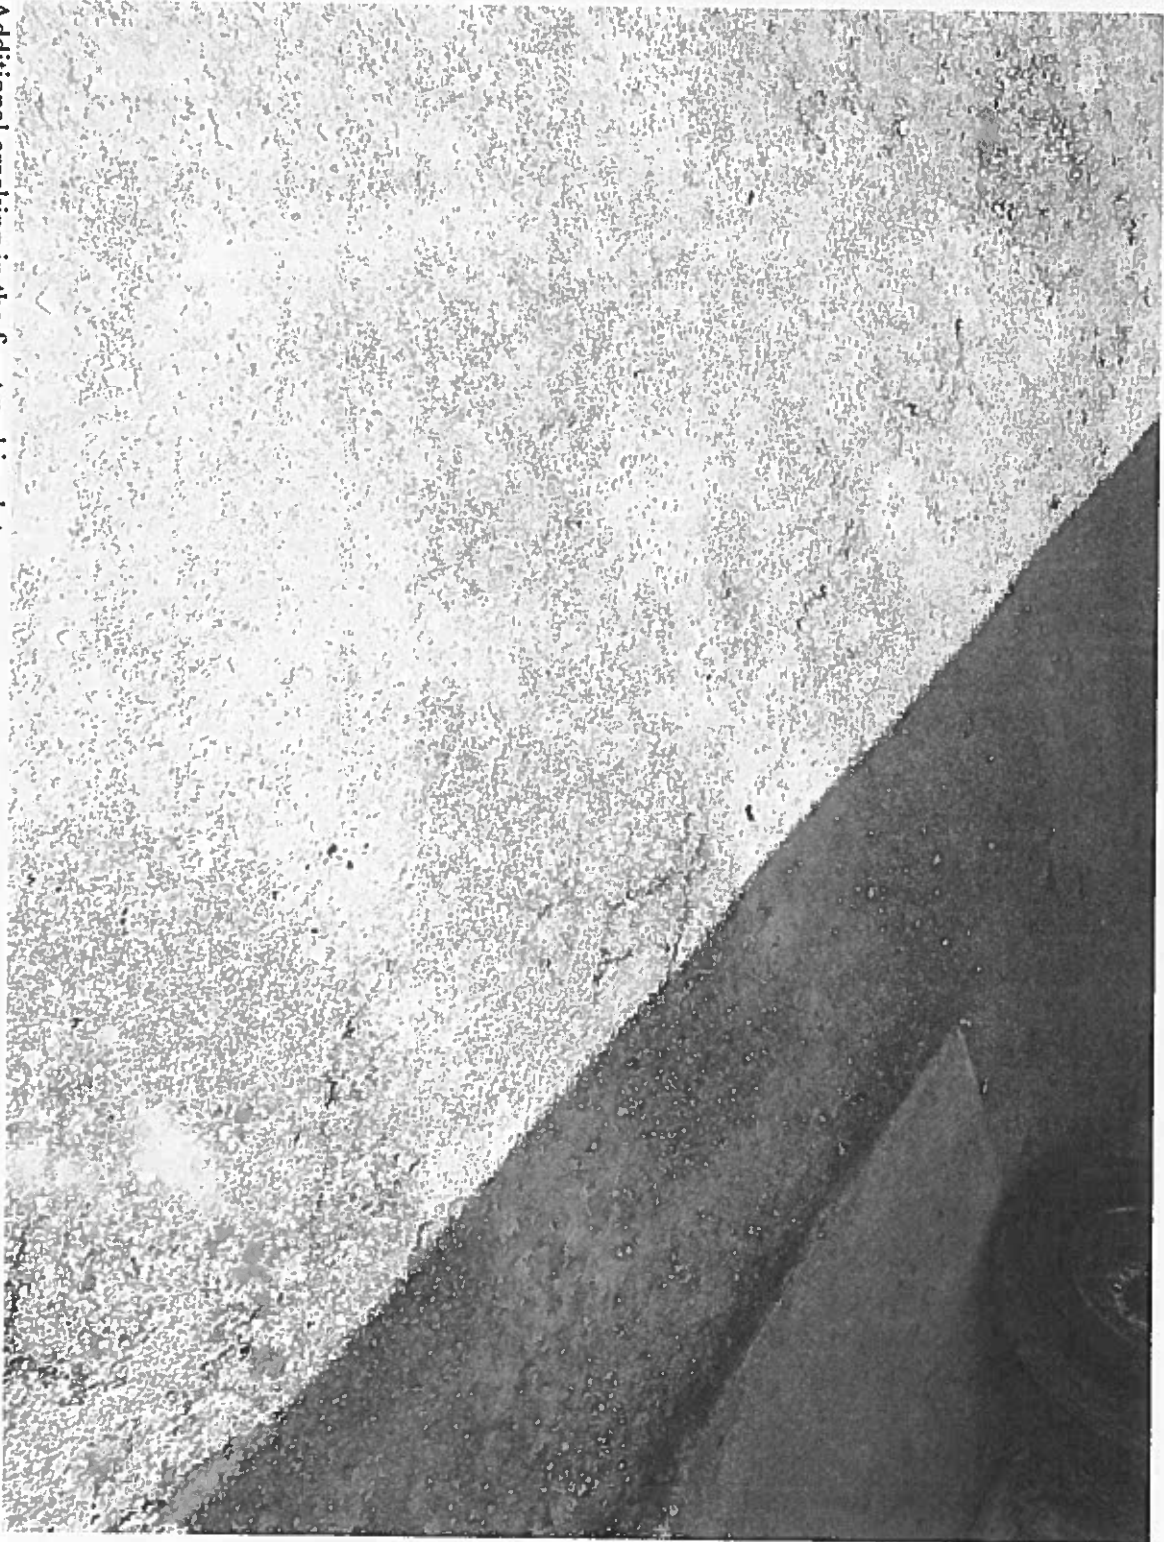
Additional cracking in the front parking lot.

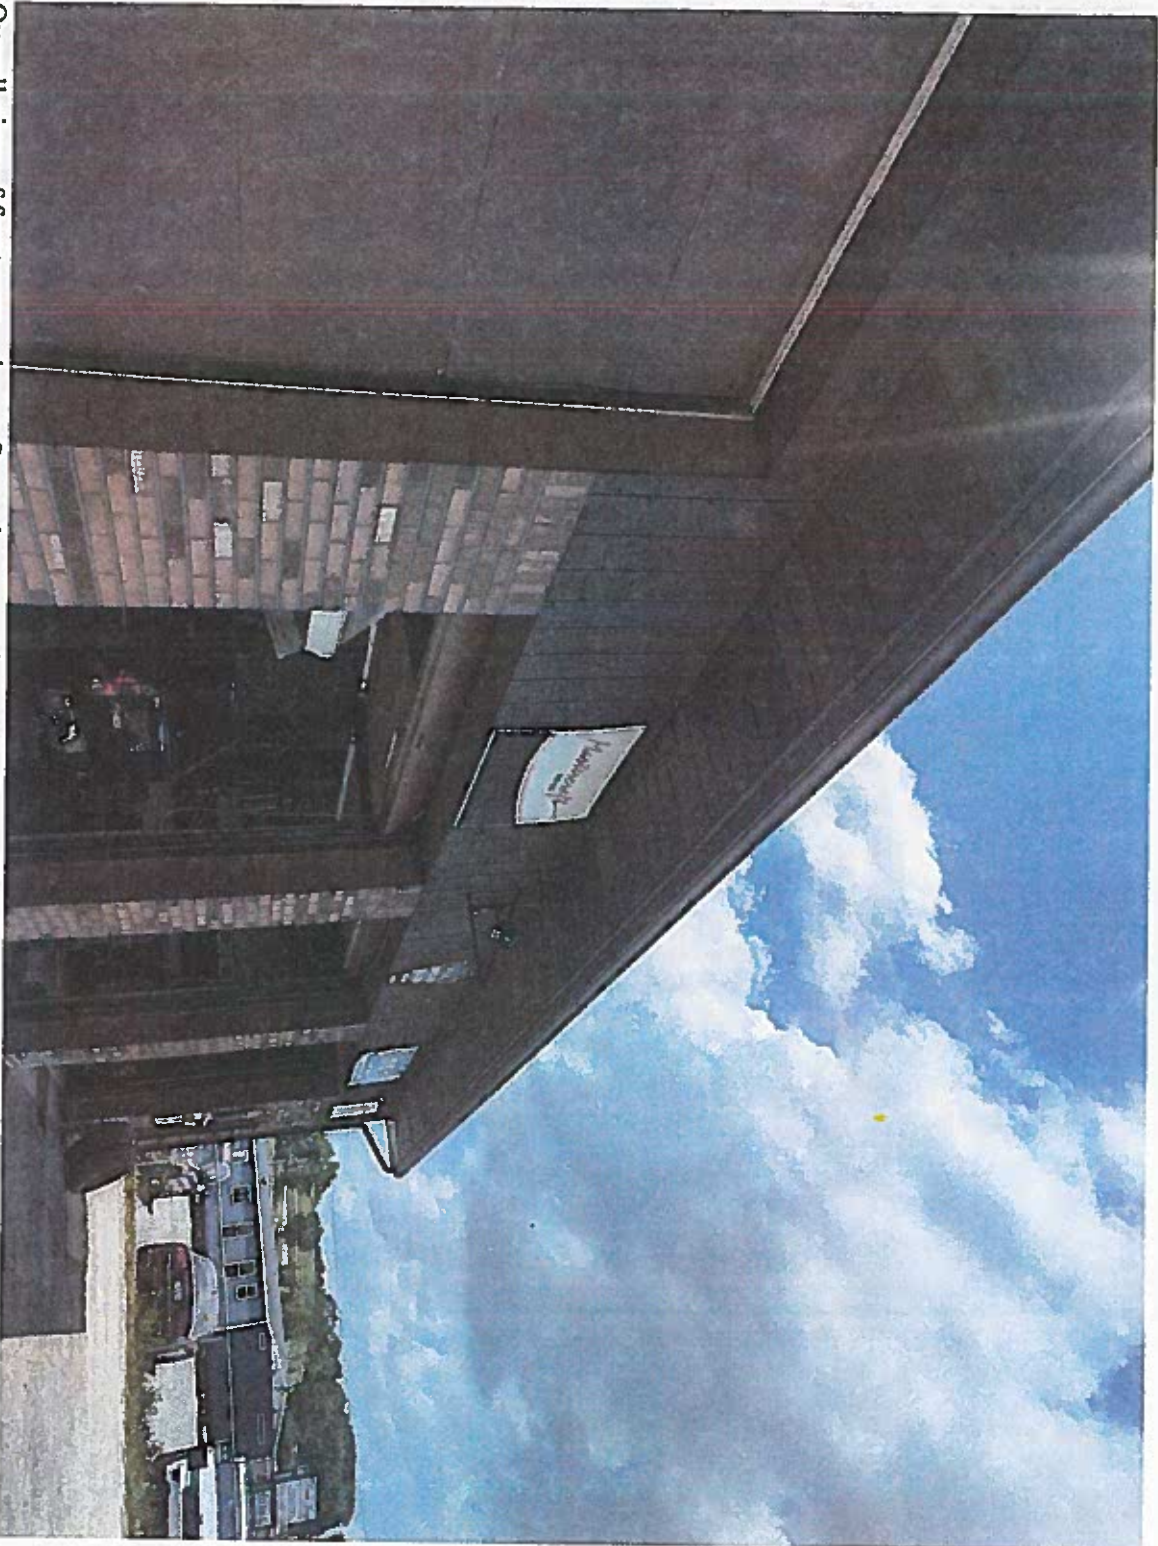
Overall view of front garage bays. Some damage at lower portions of brick pillars can be seen.
